48 Volt Lithium Battery fault current test report

Product: POATLFeLi-48100F-E

Test: Fault current

Release date: 12 October 2023

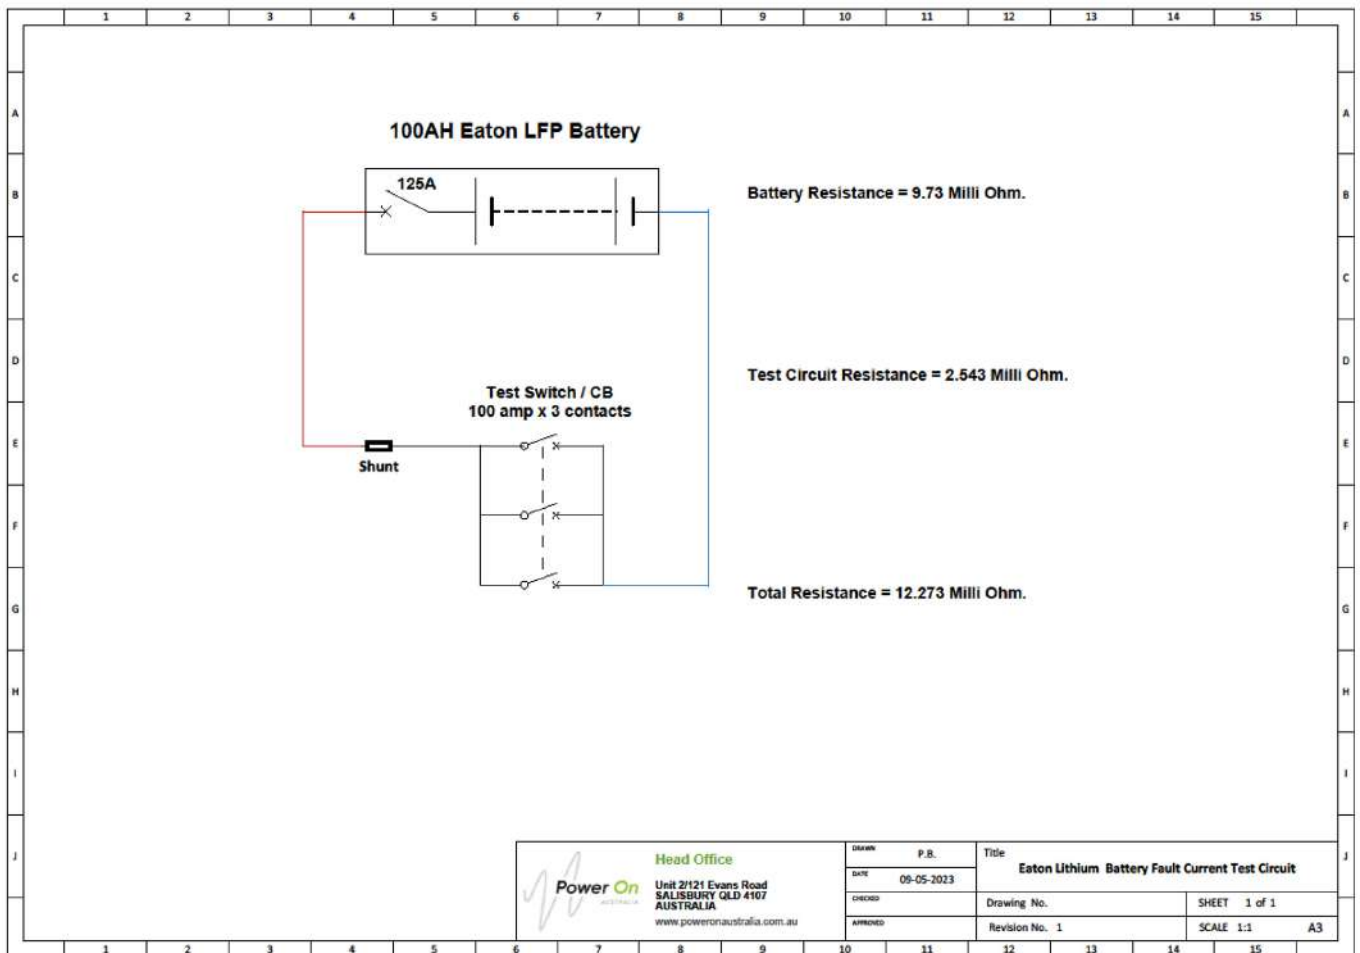
Test Circuit

The +ve and -ve of the battery were short circuited via the above wiring details with a total circuit resistance of 0.012273 ohms.

The resistance of the cables, shunt, and switch (100 amp, 3 pole CB) were measured. This was done by placing a 100-amp load through the circuit and measuring the volt drop across the circuit. The Shunt resistance with cables was measured at 0.000507 ohms and the circuit breaker was measured at 0.002 ohms.

The test circuit added extra resistance to the internal battery resistance. The actual test circuit and battery resistance was determined to be .012273 ohms, giving a theoretical fault current of 4.4kA.

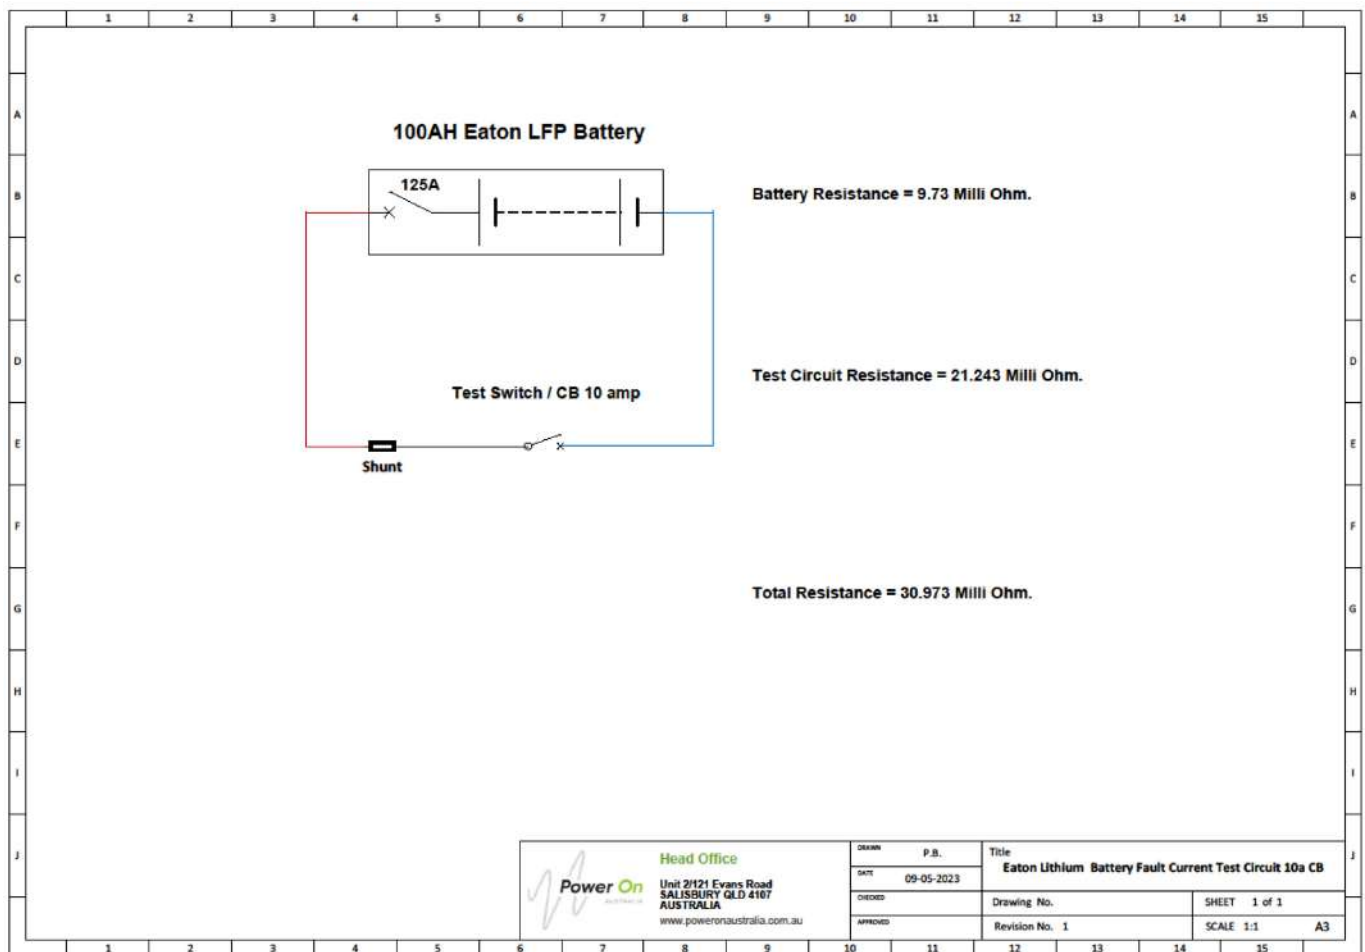
For this test only, the short circuit switch was replaced with a 10-amp ABBS201 C Curve circuit breaker. For this test, the internal resistance was calculated at 30.973 Milli Ohms for a maximum possible fault current of 1.75KA.

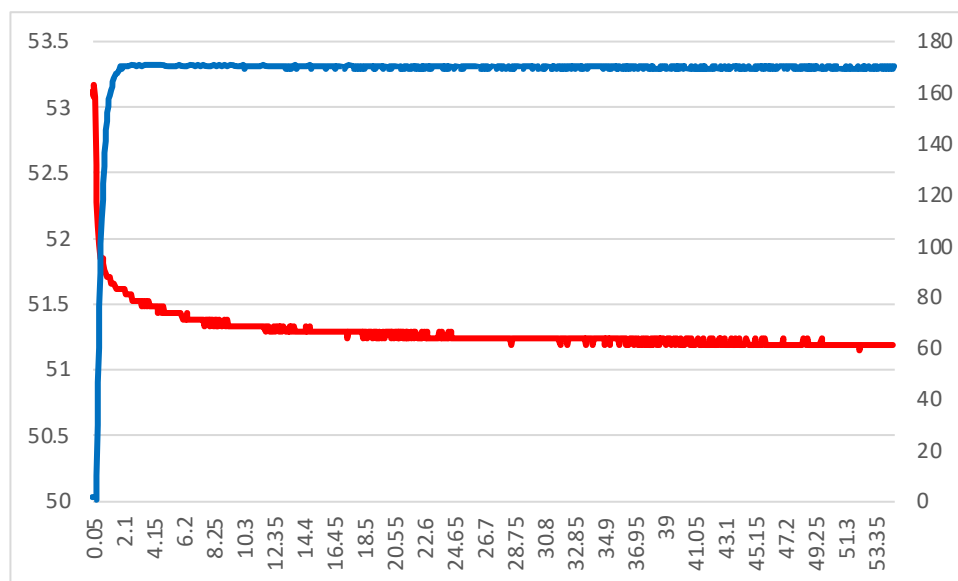
Test 5 Short Circuit. No BMS.

Test 5 is identical to test 4, but with the cable unrolled and laying on cool concrete.

A maximum current of 170.9 amps was measured.

It is noted the 125-amp circuit breaker did not trip during this test. The test was stopped by turning the supply off the battery supply manually after the cable had become hot enough for the resistance to increase sufficiently to bring the load current below 125 amps. At this point the circuit breaker will not trip (ever) but the cable will keep increasing its temperature beyond its maximum temperature and become a fire risk.

It took 2.55 milli seconds to reach full current. Note the speed to reach full current compared to Test 4. This is due to the magnetic field restricting current flow on test 4 as the cable was on a roll.

Time in Milli Seconds showing inrush event. Same time scale as Test 4 Short Circuit.

Red = Volts

Blue = Amps.

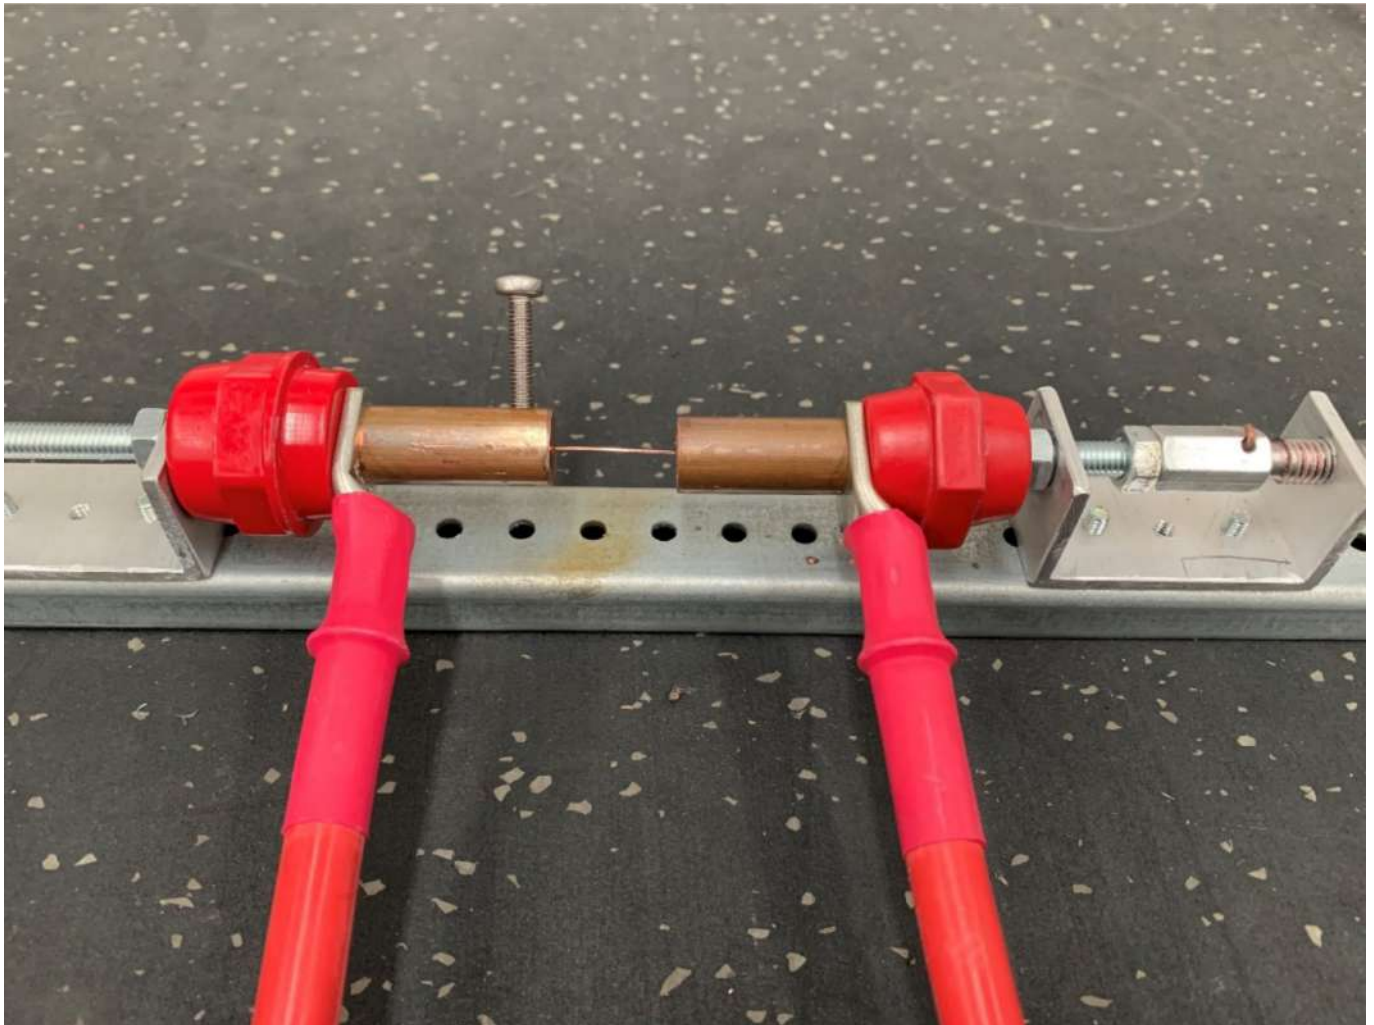
Arc test device showing a test wire ready to test.

Note: The 125-amp battery circuit breaker DID NOT TRIP with any of the Arc Tests below. In Arc Test 1 to Arc Test 6, the short circuit was broken by vaporising a gap between the +ve and -ve connections.

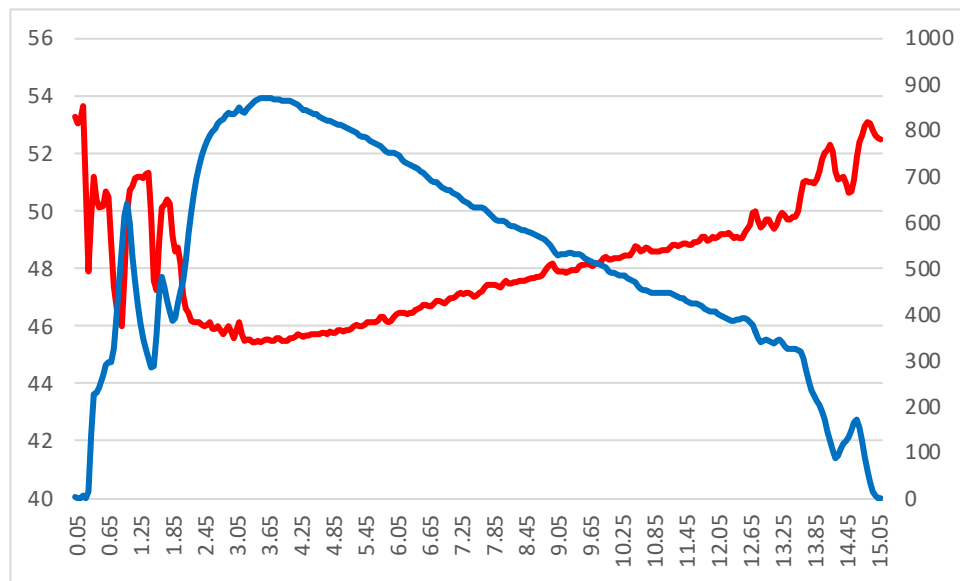
Arc Test 3. No BMS.

A 1mm² solid copper wire was square cut and fitted to the arc device. Although I didn't measure the length of wire used, this length of 1mm wire was estimated to be 10mm longer than the above lengths.

When energised, the wire burnt away a total of 7.5mm with a peak current of 872 amps. In this situation the arc cannot be supported beyond 7.5mm.

Event Joules = 378.0

Arc Flash Incident Energy = 0.00347 Cal/cm². Category 0.

Arc Flash Boundary = 24.5 mm

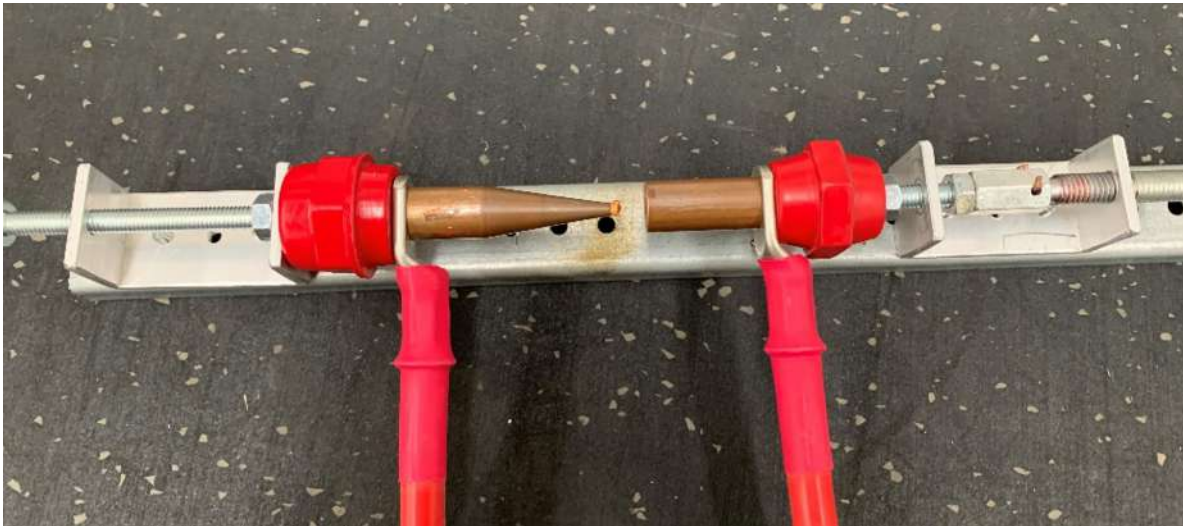
Arc Test Device with copper rod after testing.

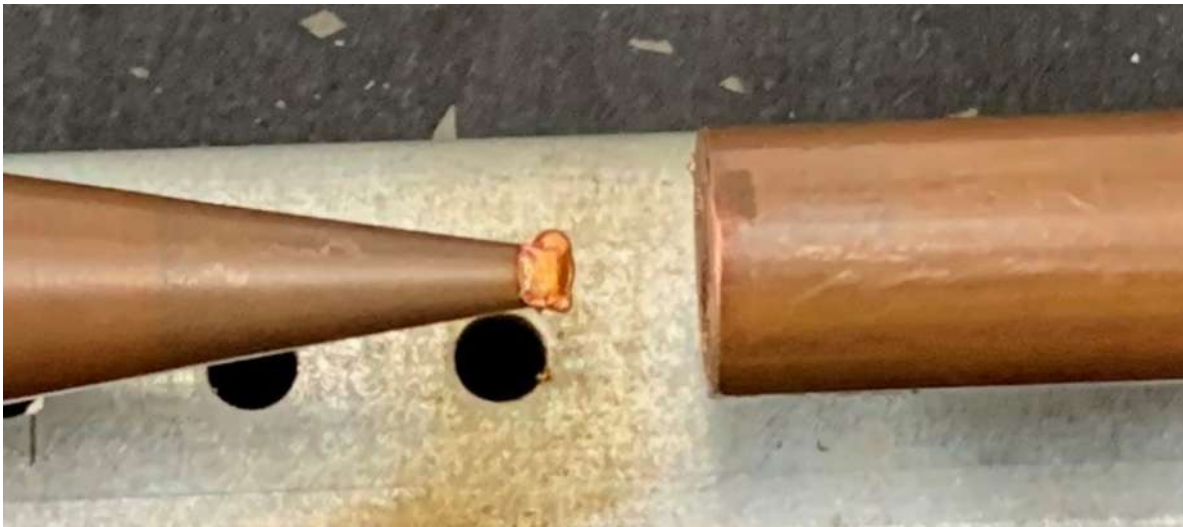
Arc Test Device showing the remains of the rod after Arc Test 6.
Note the gap is 5.6mm but the burn marks are out to 7.5mm.

When energised, the rod burnt away a total of 5.6mm with a peak current of 930 amps. Although the gap was 5.6mm, it appears the arc did reach approximately 7.5mm along the rod. The end of the rod was rounded with definite metal vaporisation out to approximately 7.5mm. Another point to note is the extended duration and higher energy Joules of this event compared to the previous Arc Flash events. The assumption here is more copper to burn away takes a longer time and more energy. This Arc Event released the highest energy.
